Façade Report

131 Lonsdale Street, Melbourne CBD

Title	Façade Survey		
Ref			
Report Date	June 2011		
Inspection Dates	May 2011		
Rev No#	0	Date	N/A
Author	Mr Clive Austin		
Signature

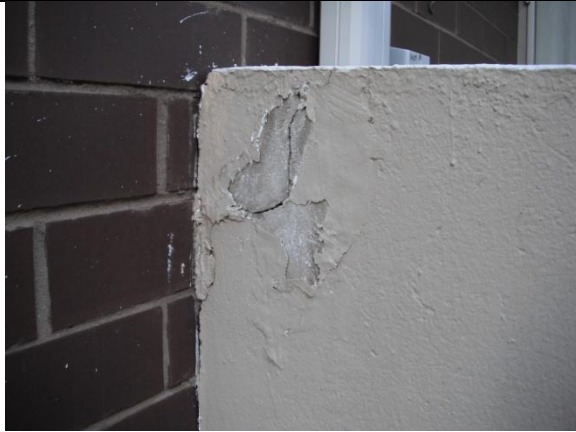
Ph #5471. Level 15. Cracking in render

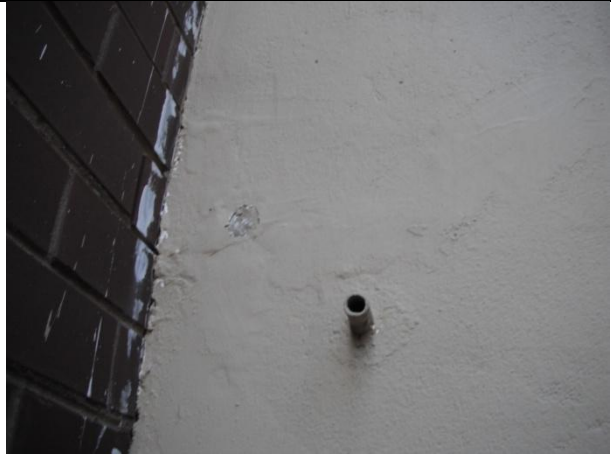
Ph #5473. Level 14 Efflorescence on brickwork. Cracking in render

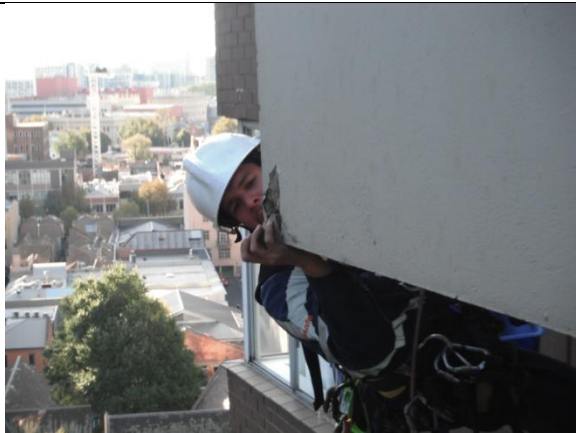
Ph #8561. Level 14 Cracking & loose render in lower corner balcony

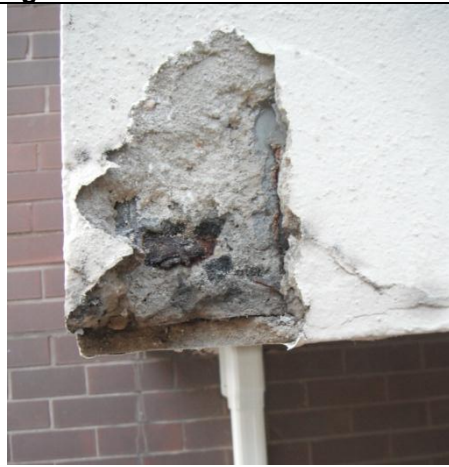
Ph #8564. Level 14 Close of previous photograph

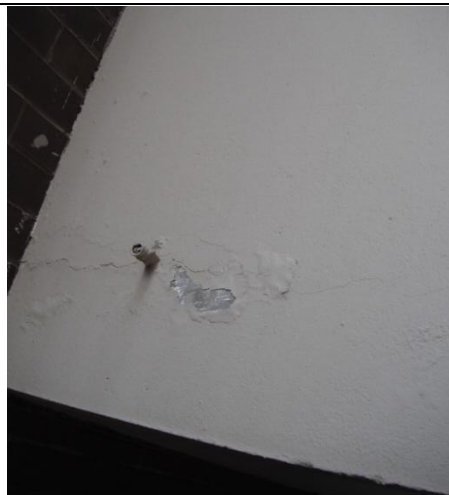
Ph #5480. Level 11. Paint Spalling & Drummy Render

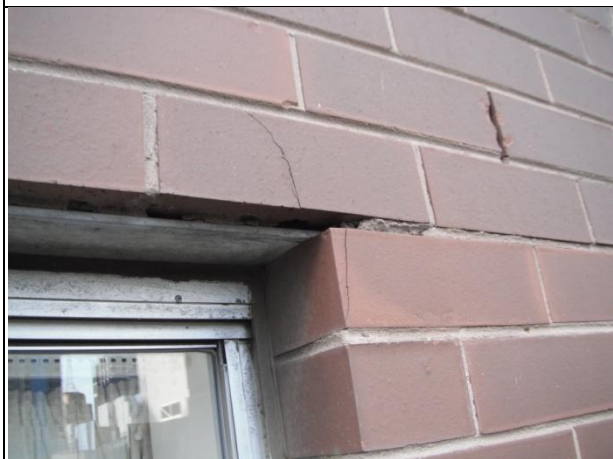
Ph #8586 Level 5. Cracking around springing line

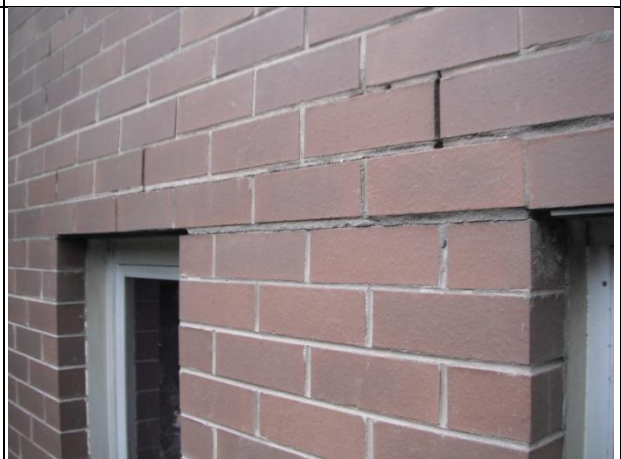
Ph #8591 Level 3. Horizontal Brickwork Displacement

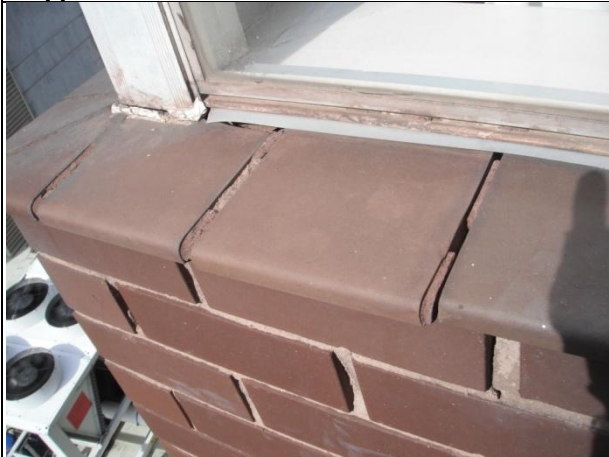
Ph #5493. Level 16. Loose window sill tile

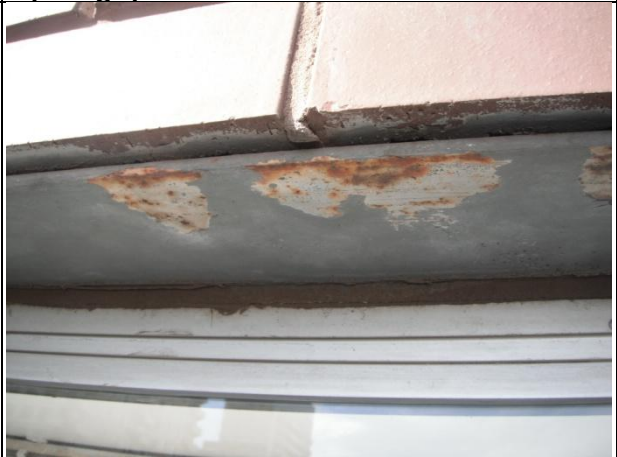
Ph #5487. Brickwork lintel onset of surface corrosion.

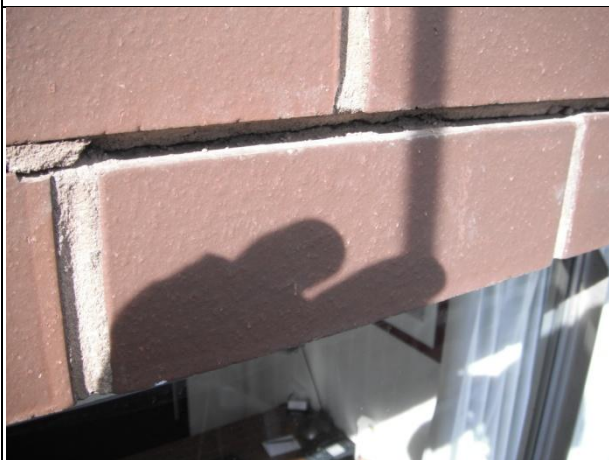
Ph #5489. Level 11 Brickwork mortar failure

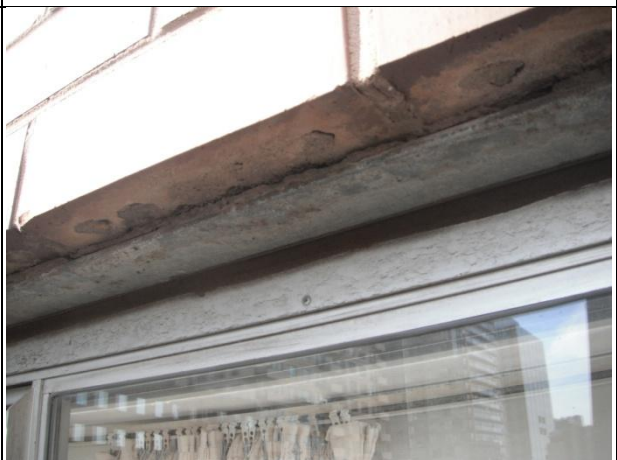
Ph #5490. Level 9. Loose mortar between bricks and lintel

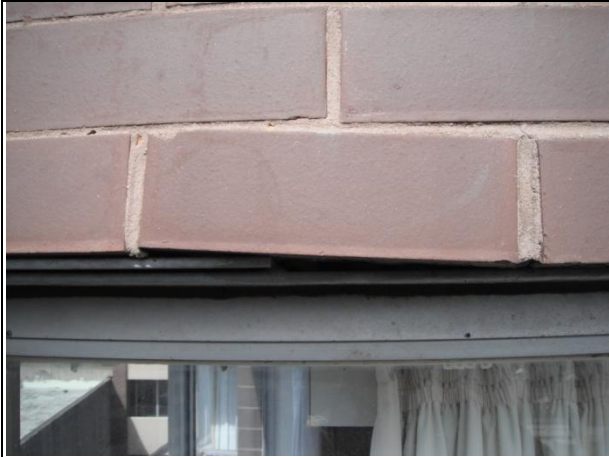
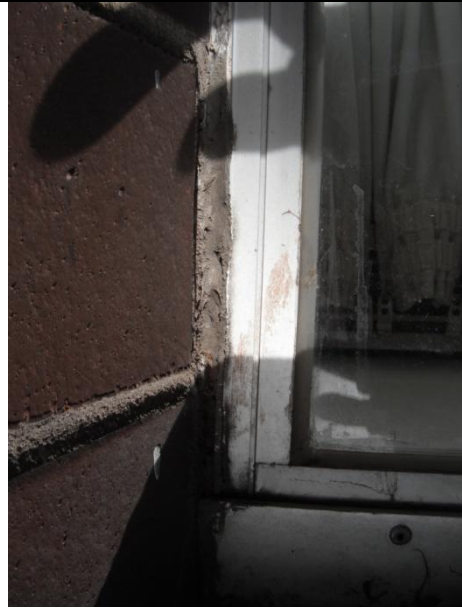
Ph #5494. Level 13 Inherent issue with partial lintel support when laying bricks. Original construction

Ph #5495. Level 12 Poor quality caulking

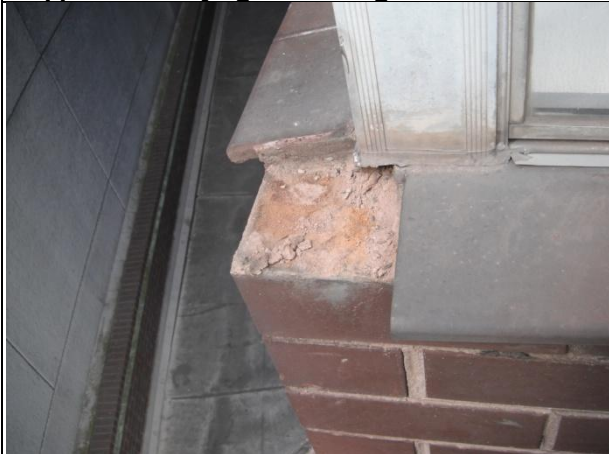
Ph #5491. Level 4 Tile loose. Removed for public safety

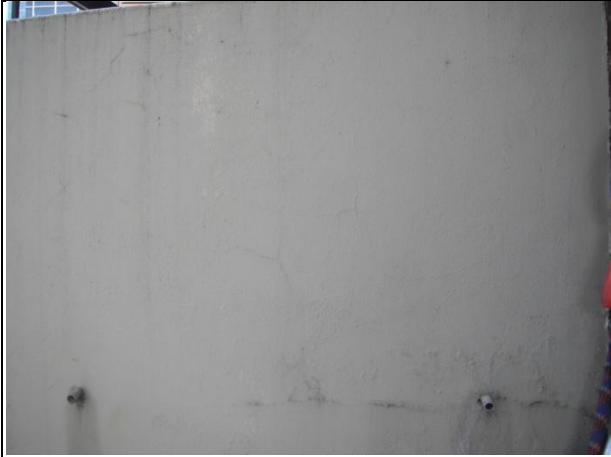
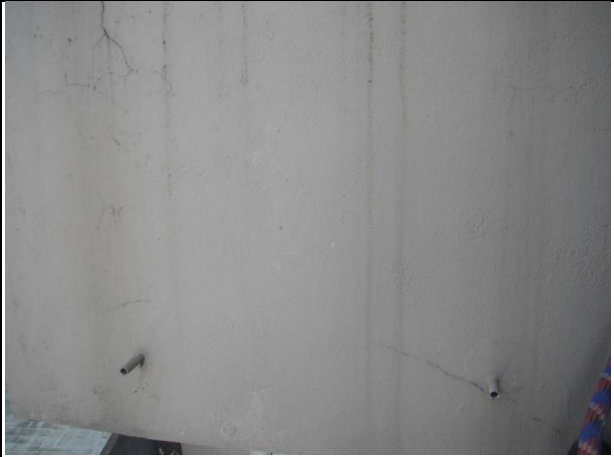
<p>Ph #5100. Level 17 Rendered balcony face 60% drummy & cracked</p>	<p>Ph #5101 Level 16. 30% drummy & cracked</p>

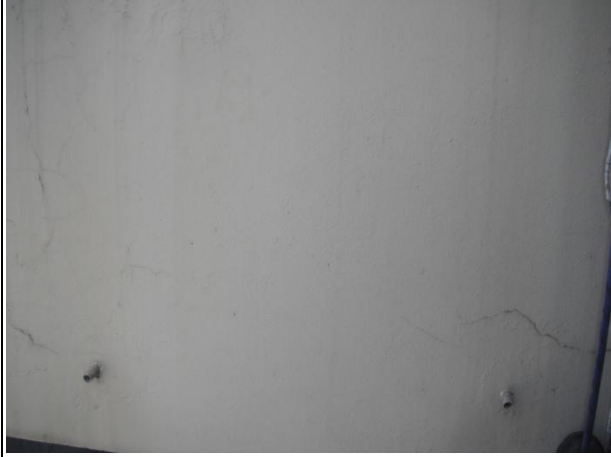
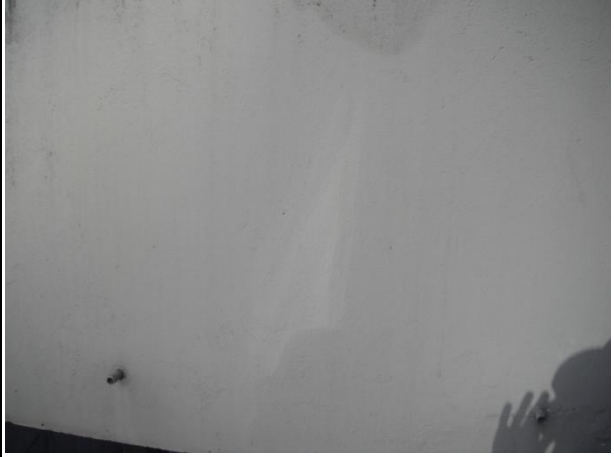
<p>Ph #5102 Level 15. 60% drummy and cracked – above drainage outlet</p>	<p>Ph #5103 Level 14. 60% Drummy</p>

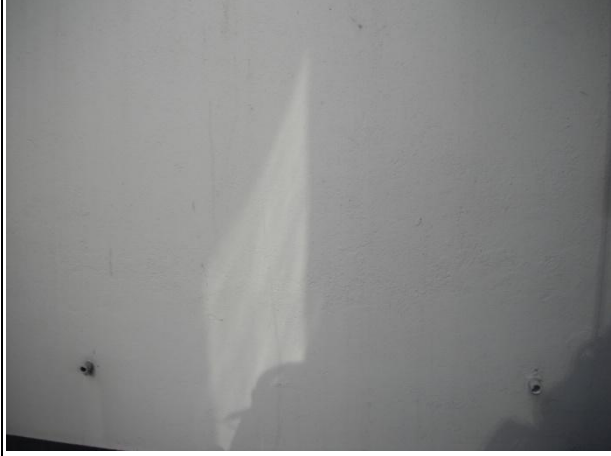
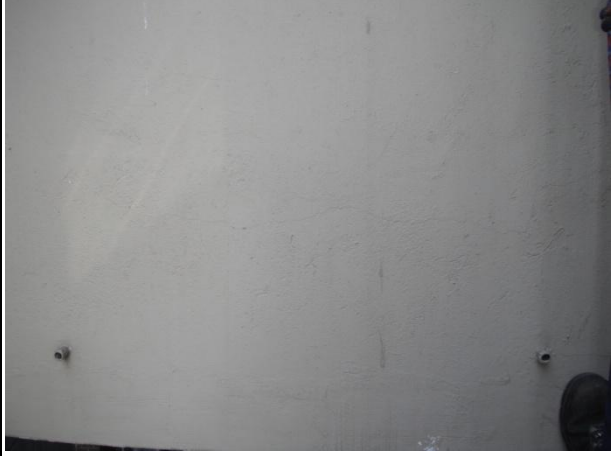
<p>Ph #5104 Level 13 30% Drummy</p>	<p>Ph #5105 30% Drummy</p>

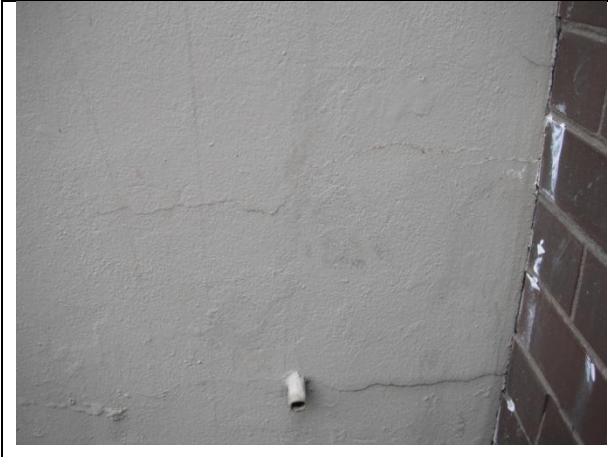
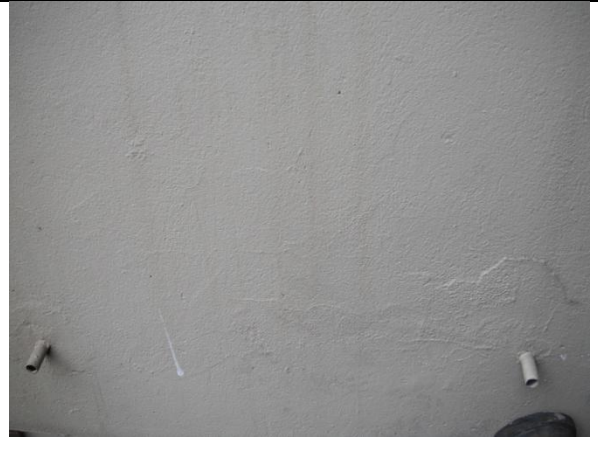
<p>Ph #5115. Level 17. 20% Drummy & 2 cracks</p>	<p>Ph #5118 Level 16 20% Drummy & small crack</p>

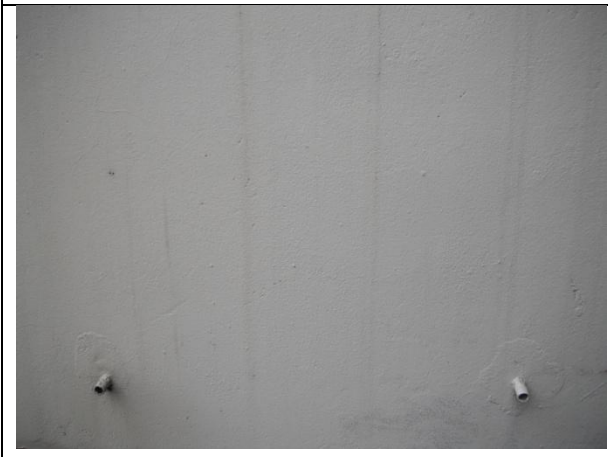
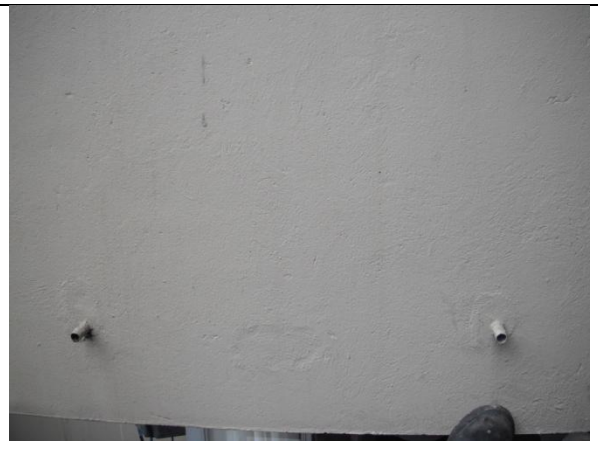
<p>Ph #5119 L15 10% Drummy Render</p>	<p>Ph #5120 Level 14 20% Drummy Render</p>

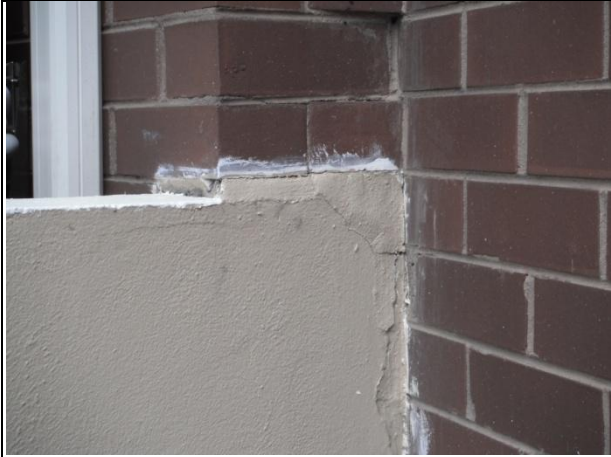
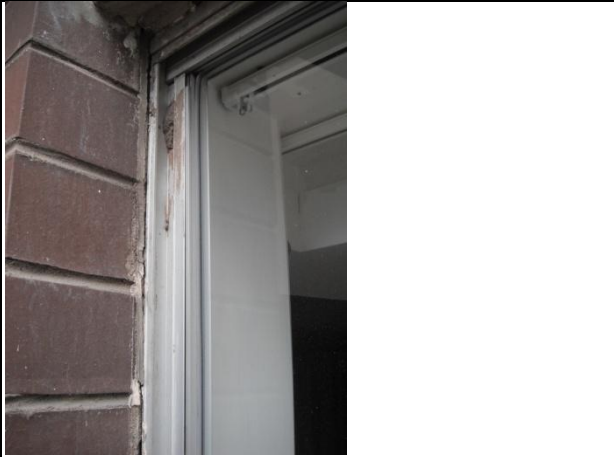
<p>Ph #5498 Level 17 Crack on corner of balcony render</p>	<p>Ph #5499. Level 15. Caulking between window frame & brickwork needs replacing – displaced.</p>

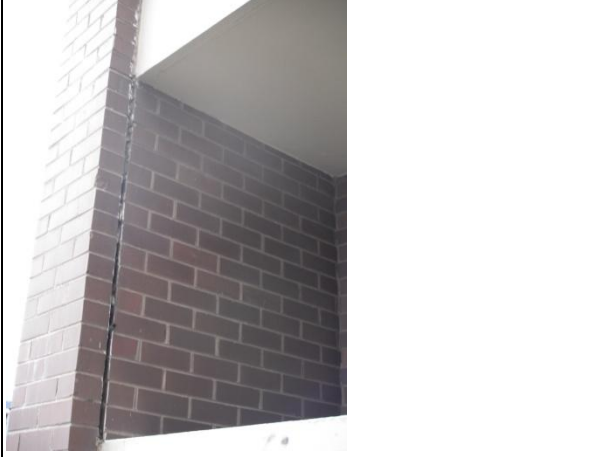
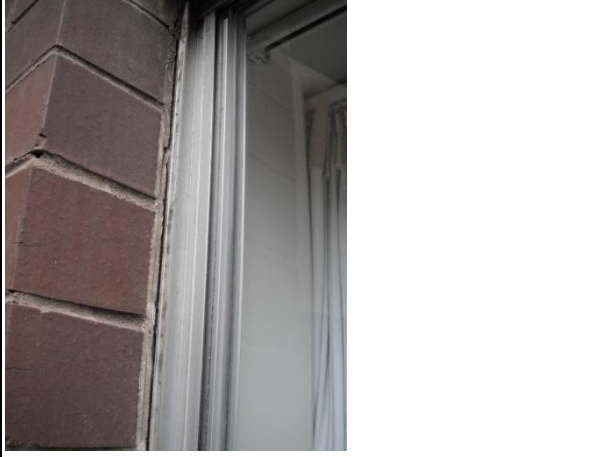
<p>Ph #5500. Level 15 Caulking missing from joint</p>	<p>Ph #5501. Level 13. Caulking between brickwork and wall</p>

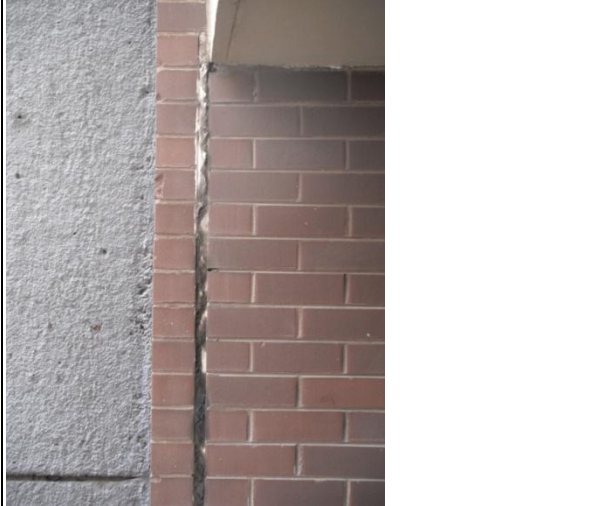
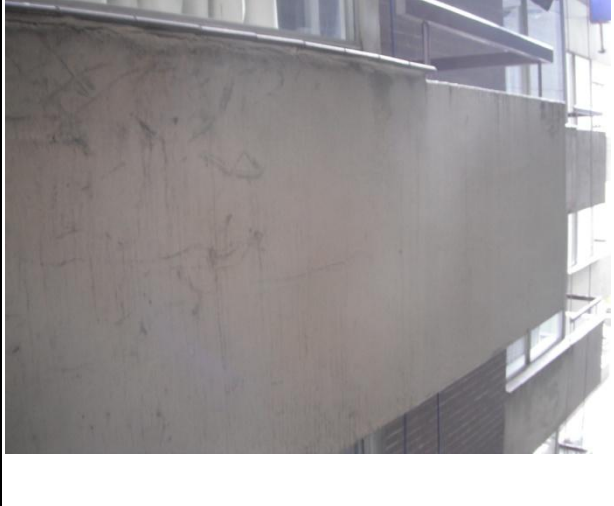
<p>Ph #5502. Level 12. Caulking from joint</p>	<p>Ph #5505 Level 3 – but similar for all other Levels. Drummy render 20-50%.</p>

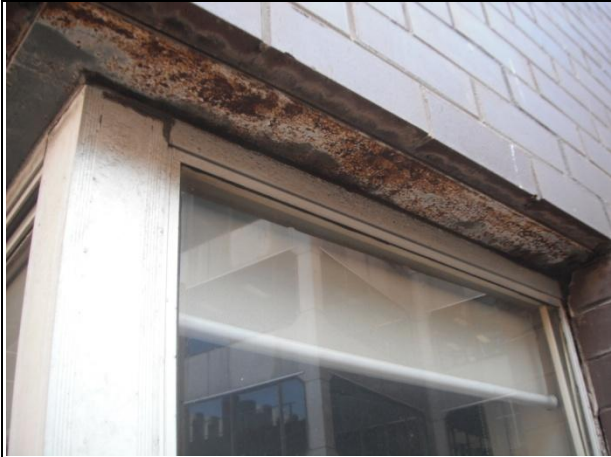
Ph #8657 Level 12 Surface Rust on exposed window Lintel

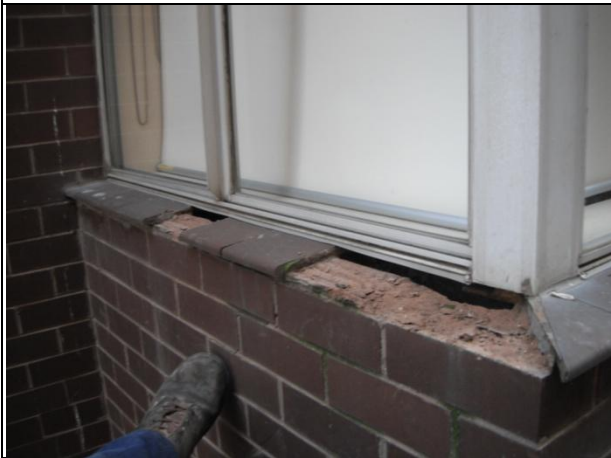
Ph #8659 Level 5 Sill Tiles Missing

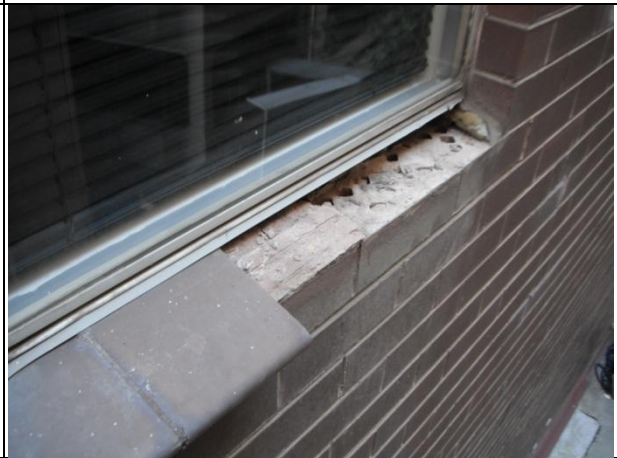
Ph #8660 Level 2 Tiles Missing

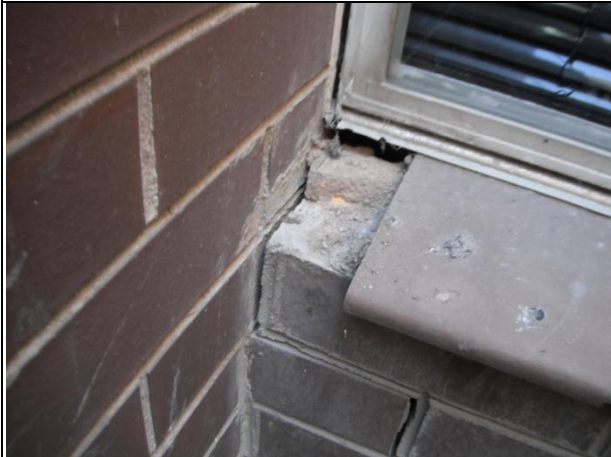
Ph #8661. Level 2 Tile Missing

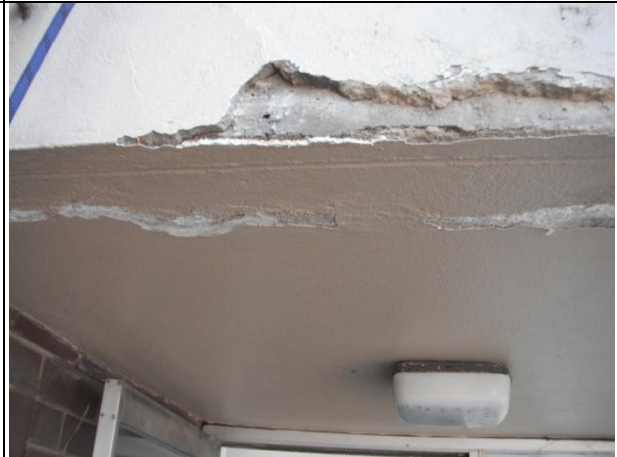
Ph #8662. Level 1 Broken Render Edge. Leak Underneath

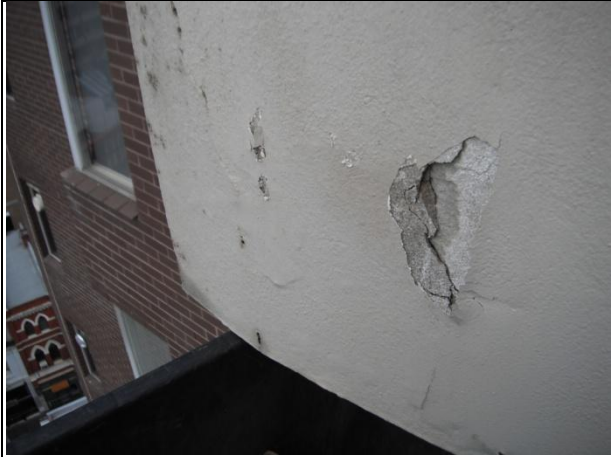
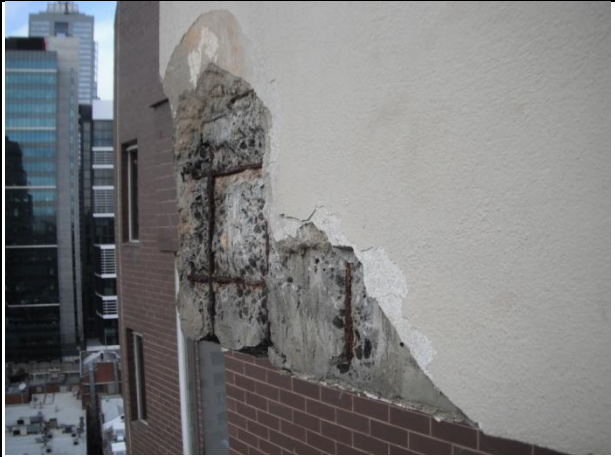
Several spalls and other failures, mainly around the corners require immediate attention as they will allow water to penetrate behind the render destabilising. There are also two instances of spalls exposing the reinforcement in the wall behind these require immediate remedial attention to avoid corroding steel further damaging the wall.

<p>Ph #8642 Level 17. Spall in render</p>	<p>Ph #8643. Level 17 Large Render Delamination. Exposing reo. In concrete substrate</p>

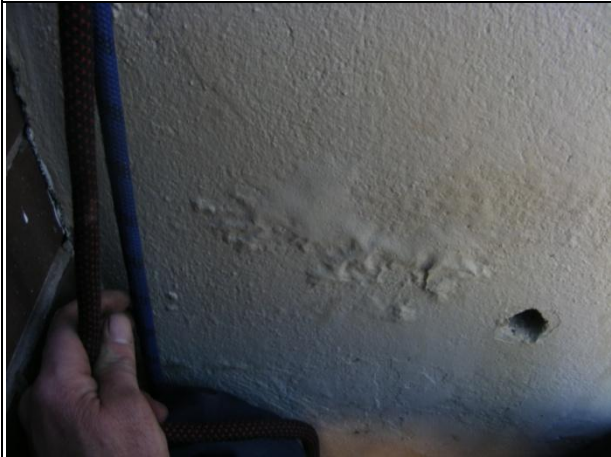
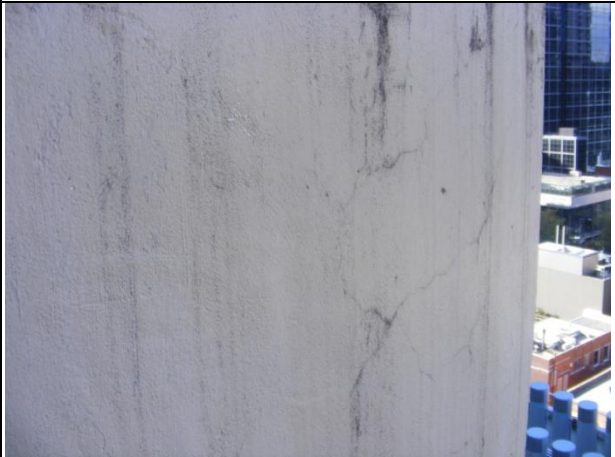
<p>Ph #8747 Level 17 Drummy reapiir – earlier</p>	<p>Ph #8748. Level 16 Cracked & Drummy Render 40%</p>

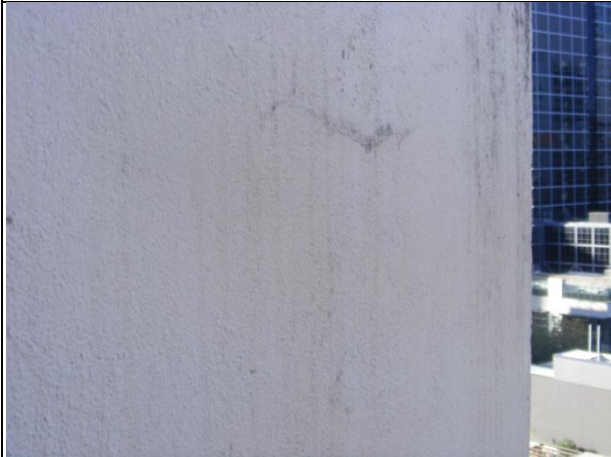
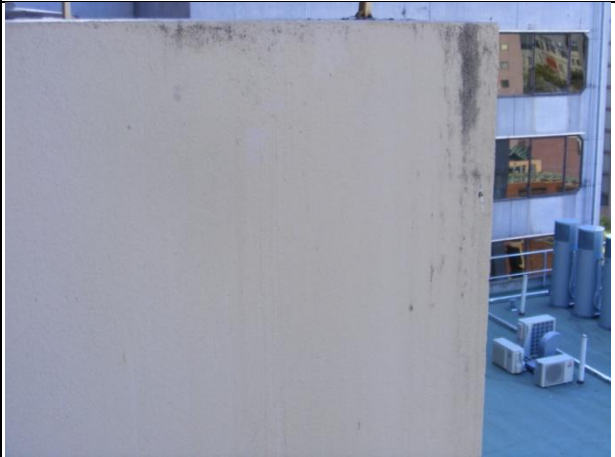
<p>Ph #8749 Level 15 Cracked & Drummy Render</p>	<p>Ph #8750 Level 14 Cracked & Drummy Render 40%</p>

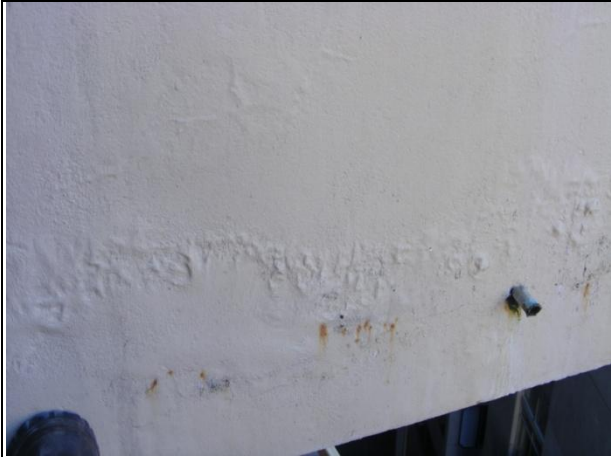
Ph #8751. Level 13 Cracked Render

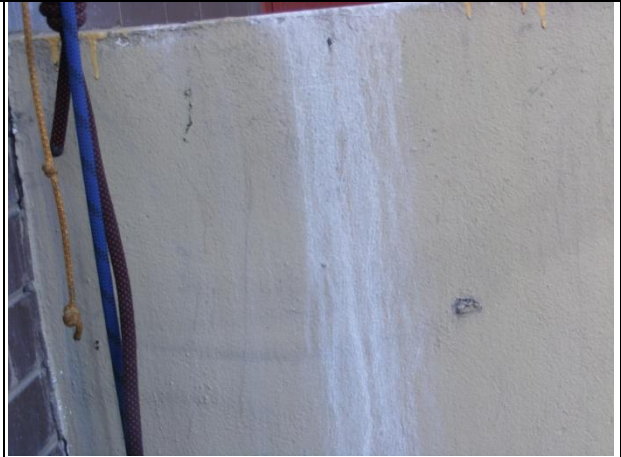
Ph #8752. Level 12. Cracked & Drummy Render. 30%

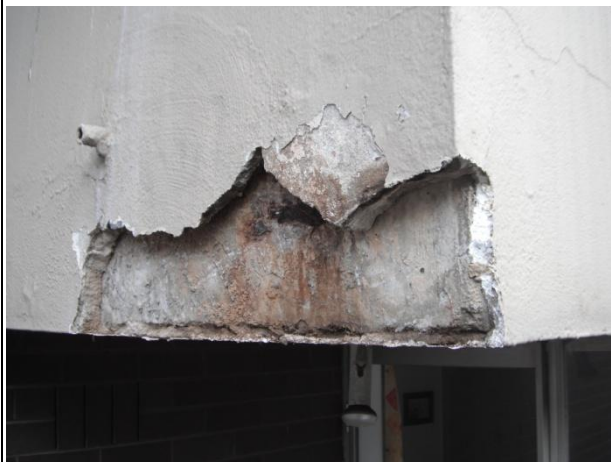
Ph #8664 Level 11 Delaminated Render on corner

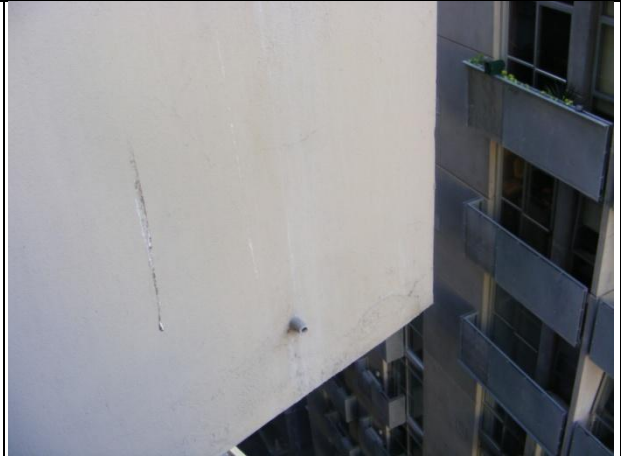
Ph #8753. Level 11 Cracked & Drummy Render. 70%

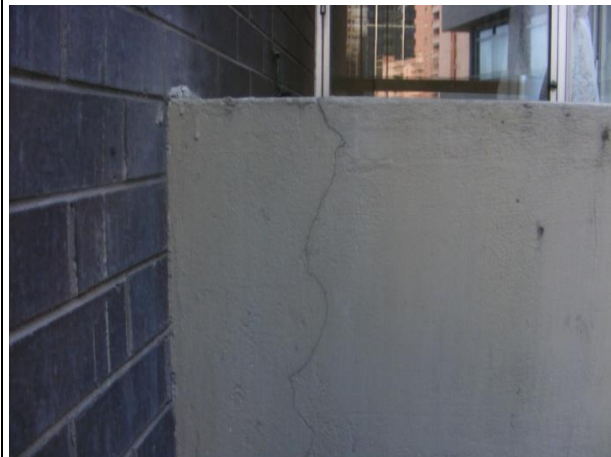
Ph #8757 Level 7 Large Crack in render

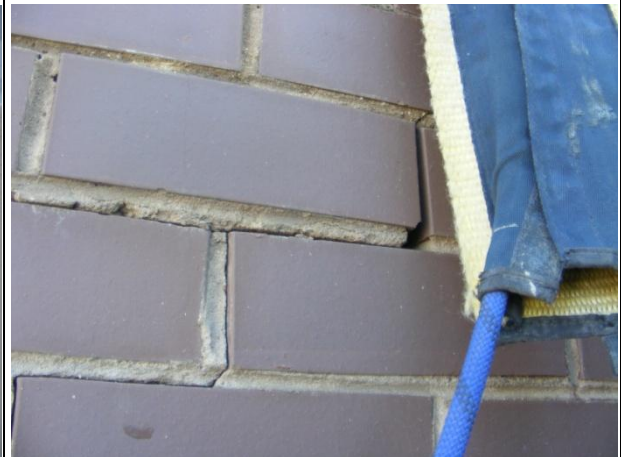
Ph #8746 Level 3 Cog cracking in brickwork

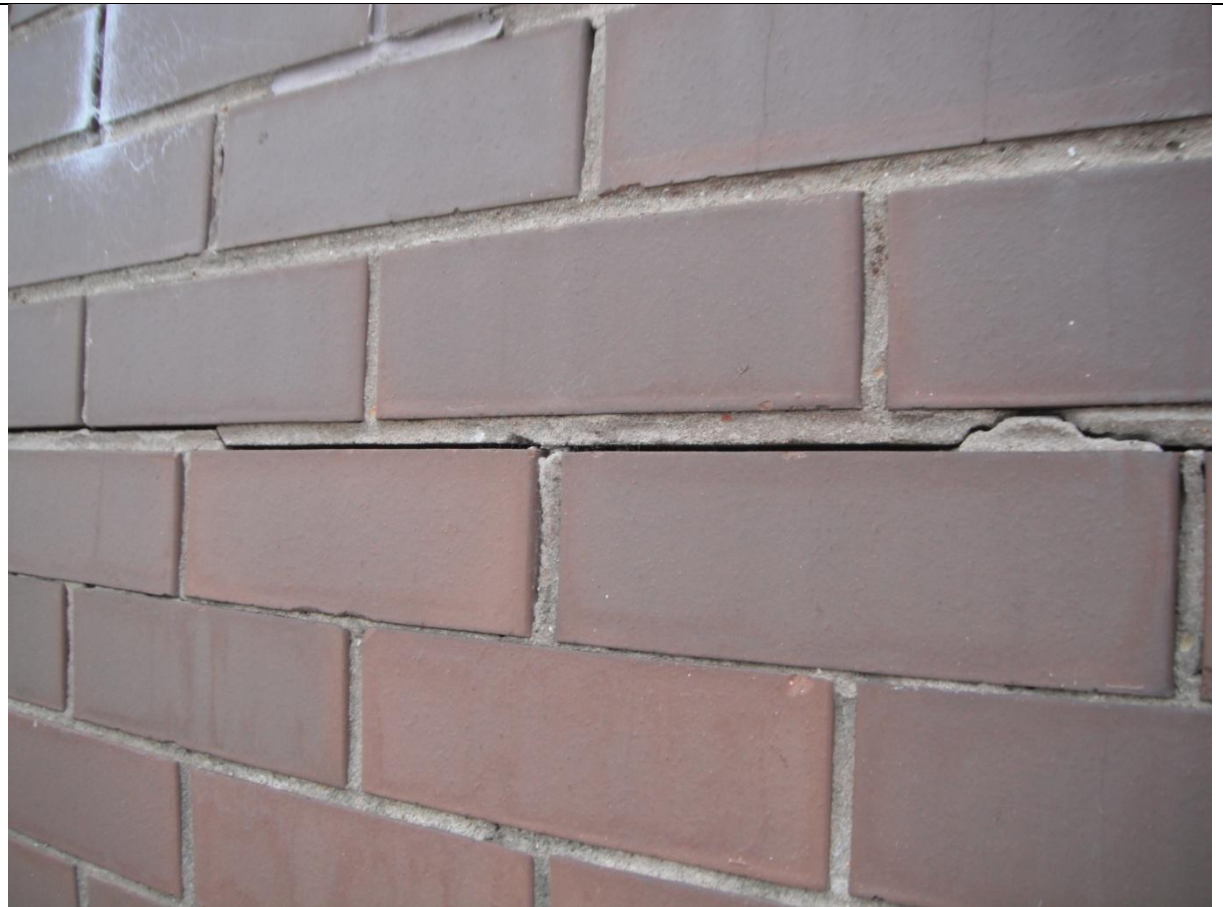
Ph #8675 Level 10. Horizontal Crack in brickwork.

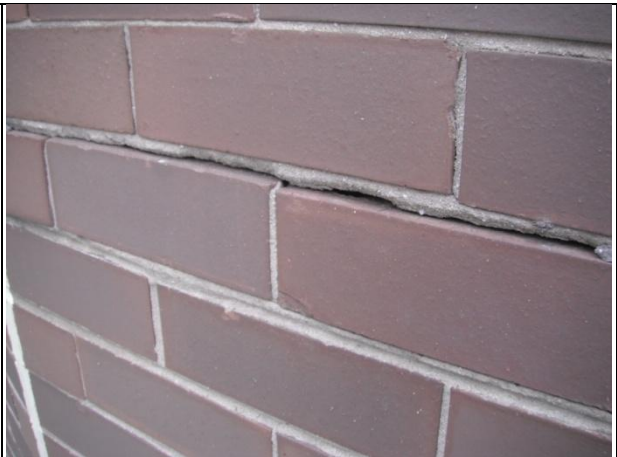
Ph #5518. Level 17. Horizontal Brickwork Crack

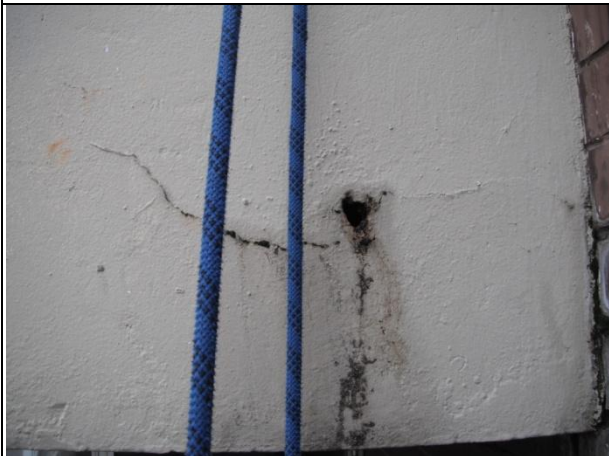
Ph #5519 Level 16 Cracked & Drummy Redner

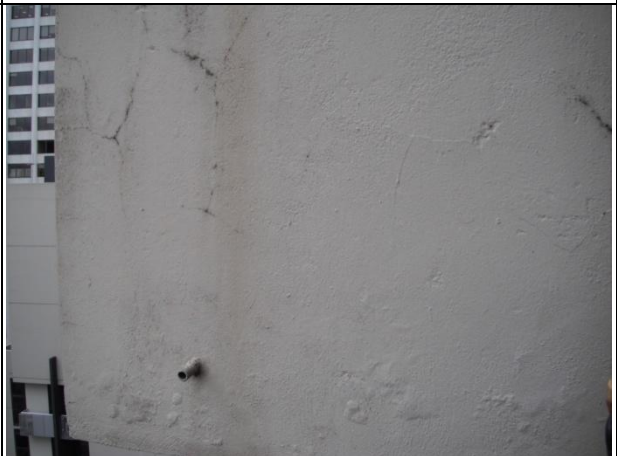
Ph #5520. Level 16 Cracked & Drummy Render

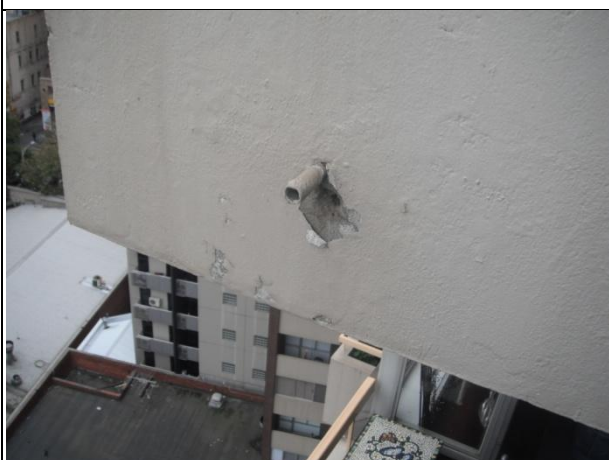
Ph #5187 Level 15. Spall around drainage outlet

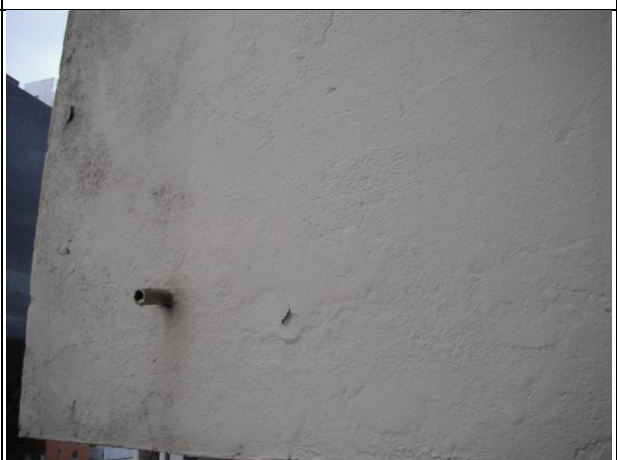
Ph #5521. Level 14. *Drummy Render. 80%

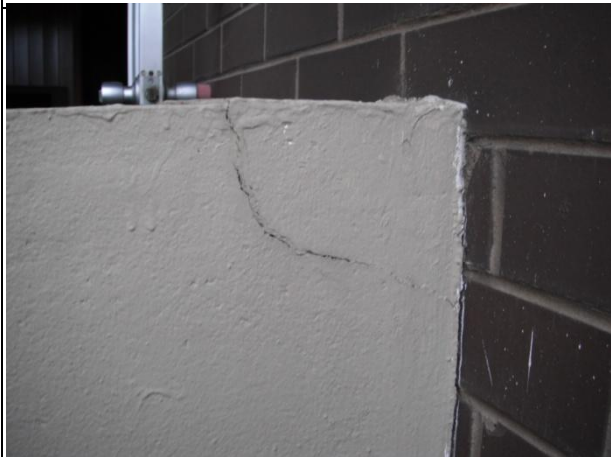
PH #5523 Level 10 Crack adjoining wall

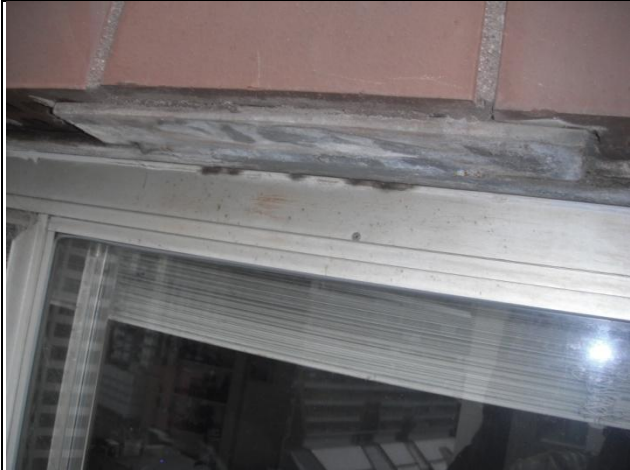
<p>Ph #5195 Level 17. Window Lintel Detail</p>	<p>Ph #5196 Level 17 Cracks in balcony render 30% drummy</p>

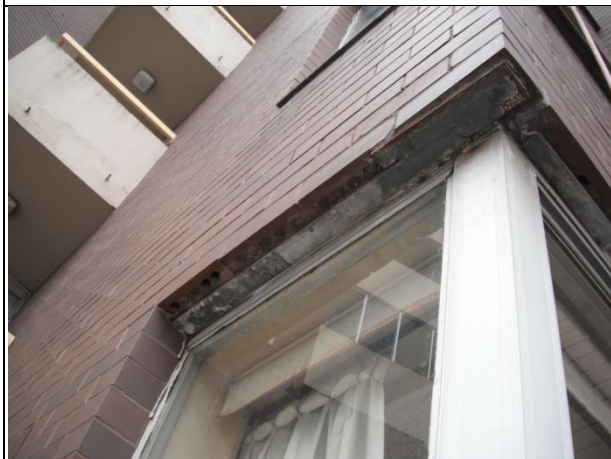
Ph #5527. Level 12 Corroded (Surface) & Lintel Detail

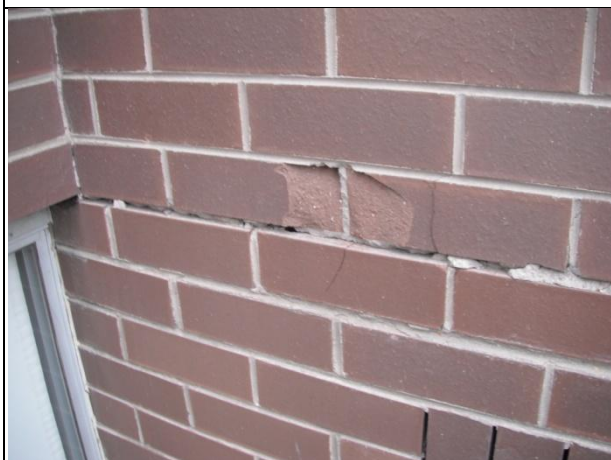
Ph #5528 Level 2 Surface Delamination of bricks

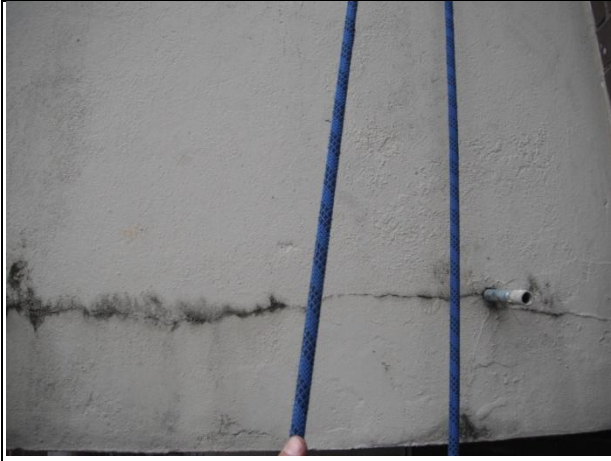
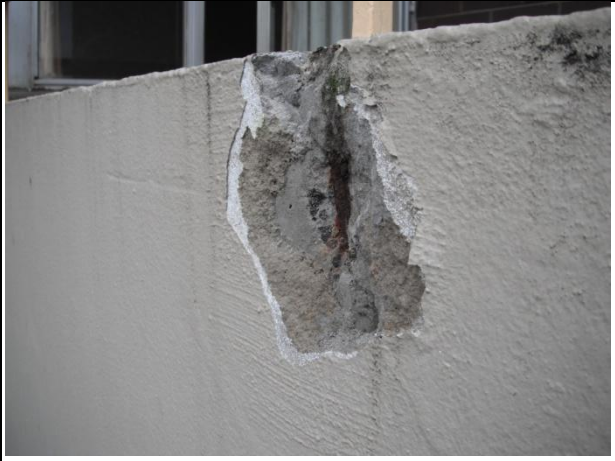
<p>Ph #5229 Level 17 Crack. Render 50% Drummy</p>	<p>Ph #5530. Level 13 Concrete Spall Corroded Reinforcement Requires repair</p>

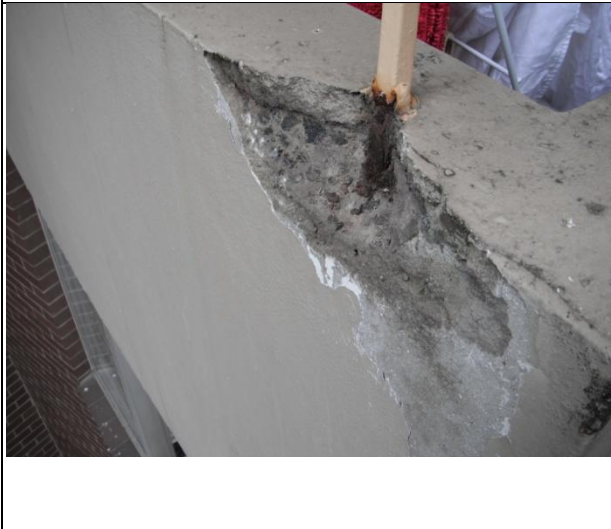
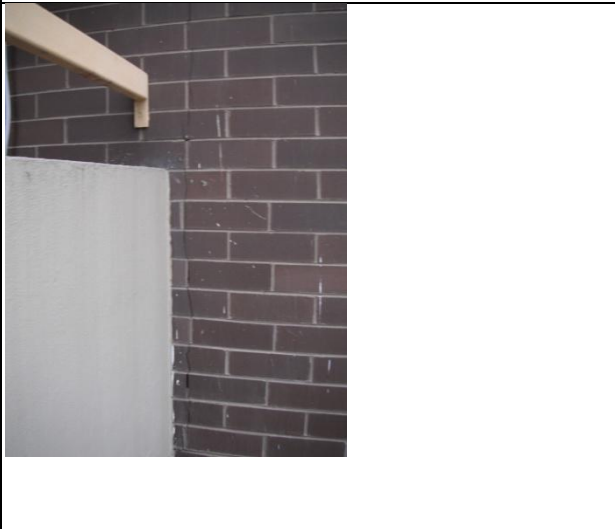
<p>Ph #5532 Level 10 13 Concrete Spall Corroded Reinforcement Requires repair</p>	<p>Ph #5533 Level 7 Vertical Crack in brickwork</p>

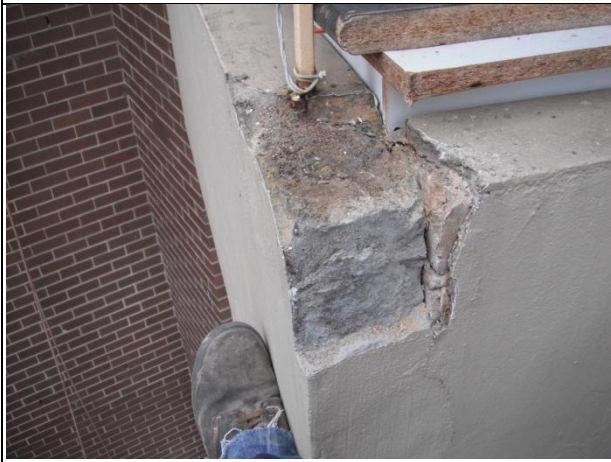
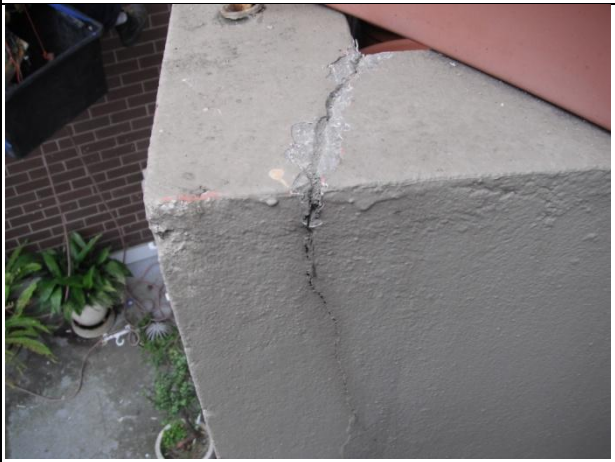
<p>Ph 5534 Level 3 Missing render on corner – cause unknown</p>	<p>Ph #5535. Level 2 Crack in render - repaired</p>

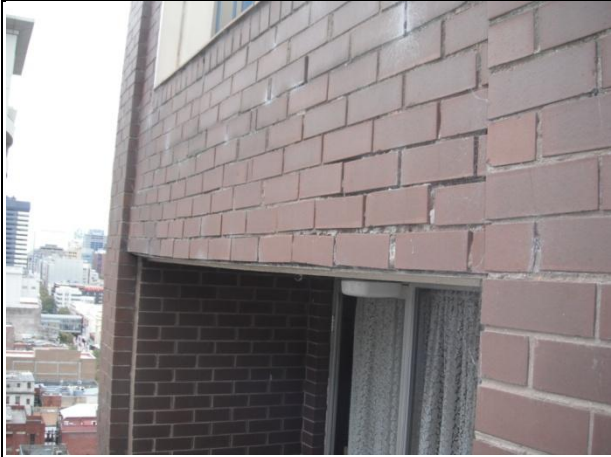
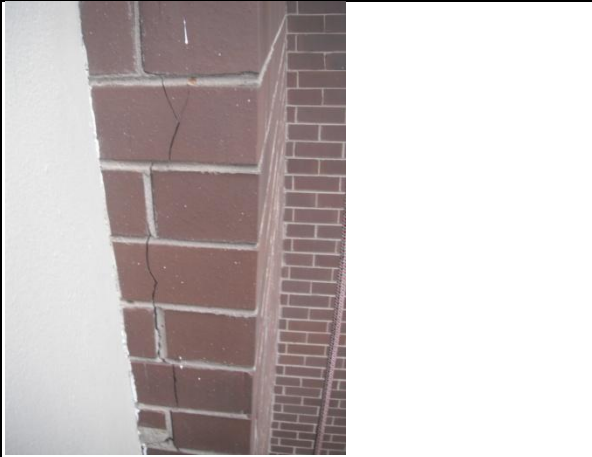
<p>Ph #5207. Level 17. Mortar missing on number of beds & perpends. Disoriented laying pattern. Note appears original construction not later movement</p>	<p>Ph 5208. Level 8 Through and Through minor crack through brickwork</p>

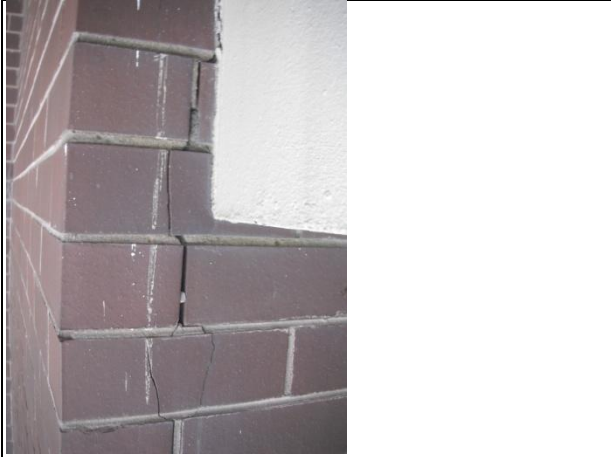
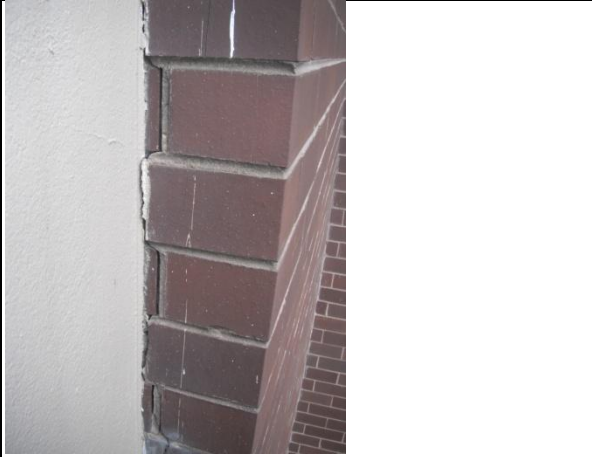
<p>Ph #5210. Level 6 Vertical through & through creacking in brickwork</p>	<p>Ph #5211. Level 6 Cracking in brickwork</p>

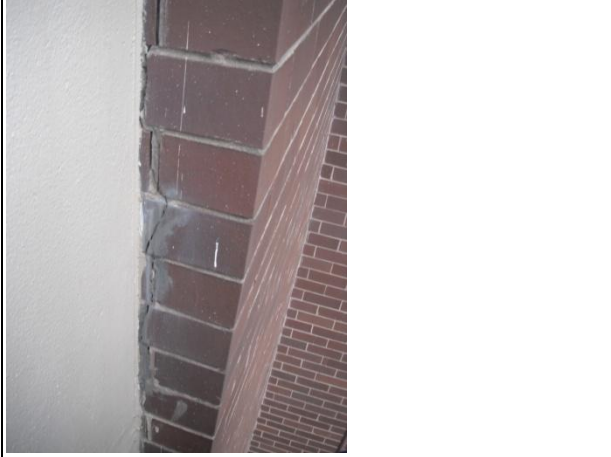
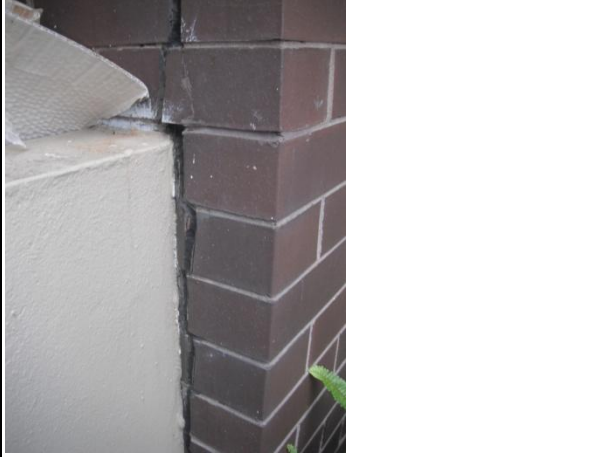
<p>Ph #5212 Level 7 Delamination & cracking of brickwork</p>	<p>Ph #5213 Level 7 Significant cracking of brickwork</p>
