Façade Report

131 Lonsdale Street, Melbourne CBD

Title	Façade Survey		
Ref			
Report Date	June 2011		
Inspection Dates	May 2011		
Rev No#	0	Date	N/A
Author	Mr Clive Austin		
Signature

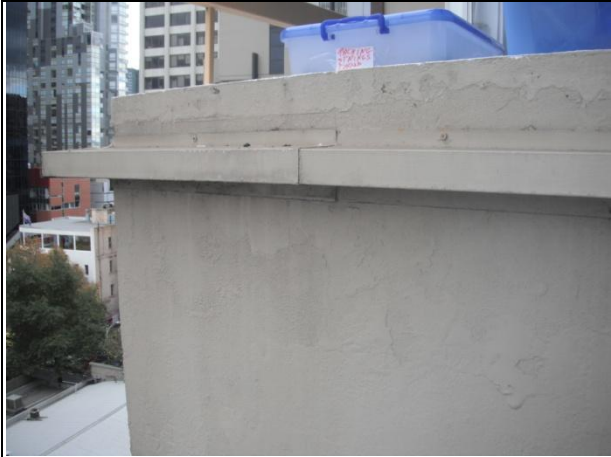
Ph #5188. Level 11 Drummy on top half of wall. 50%

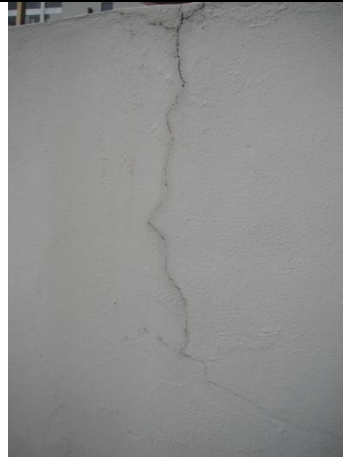
Ph #5189. Level 10 Drummy with significant vertical crack

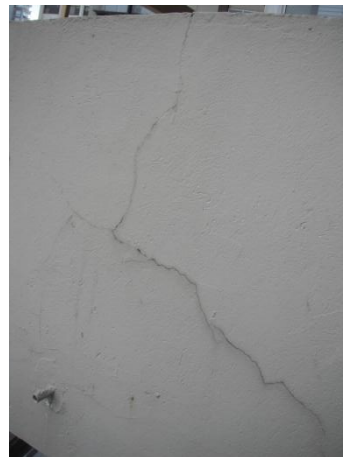
Ph #5192 Level 6. Drummy & Cracked render 30%

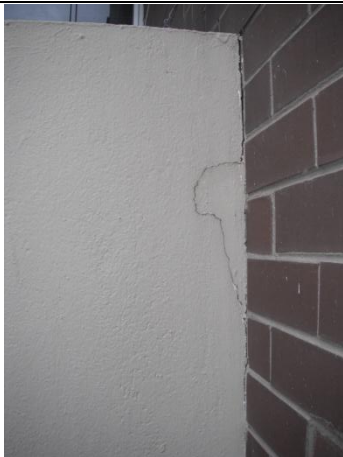
Ph #5194 Level 4 Crack adjoining brickwork
