Façade Report

131 Lonsdale Street, Melbourne CBD

Title	Façade Survey		
Ref			
Report Date	June 2011		
Inspection Dates	May 2011		
Rev No#	0	Date	N/A
Author	Mr Clive Austin		
Signature

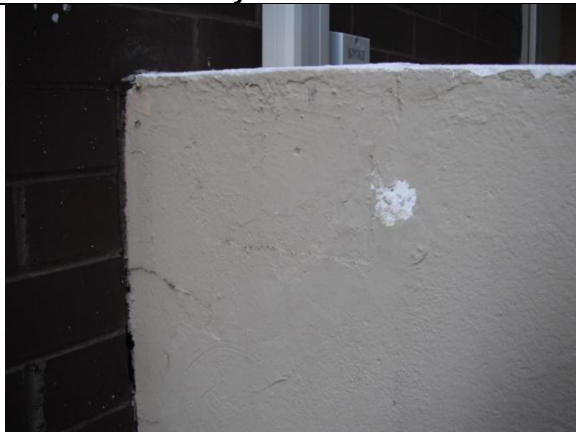
Ph #5475. Level 13 Paint film loss & drummy render

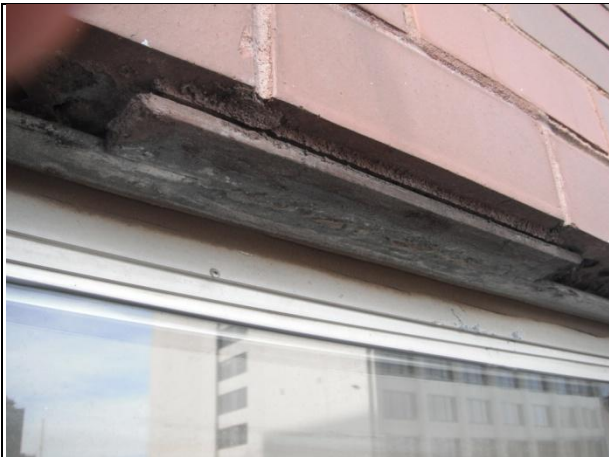
Ph #5481 Level 17. Detail of window lintel brickwork support

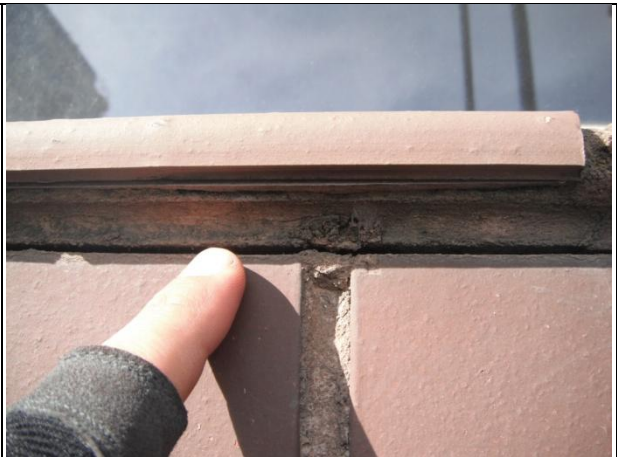
Ph #5484. Level 16 Underneath window tile. Gap opening up

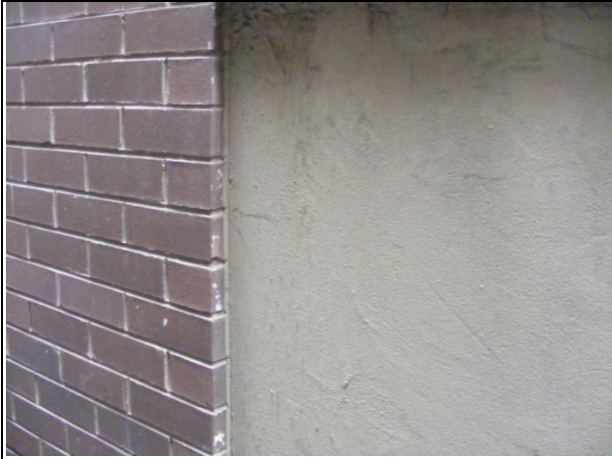
Ph #8737. Level 9. 45% Drummy

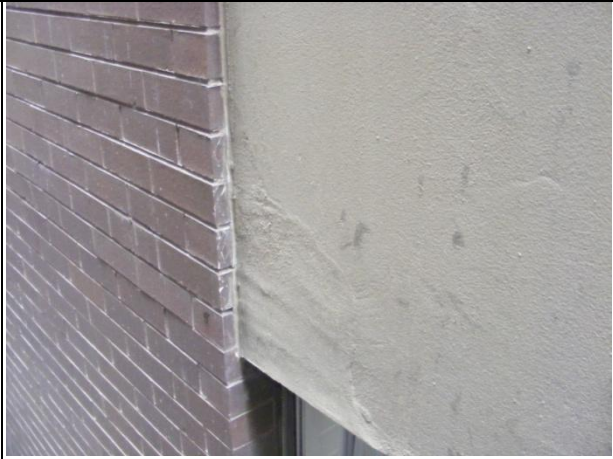
Ph #8740. Level 6. Extremely Drummy

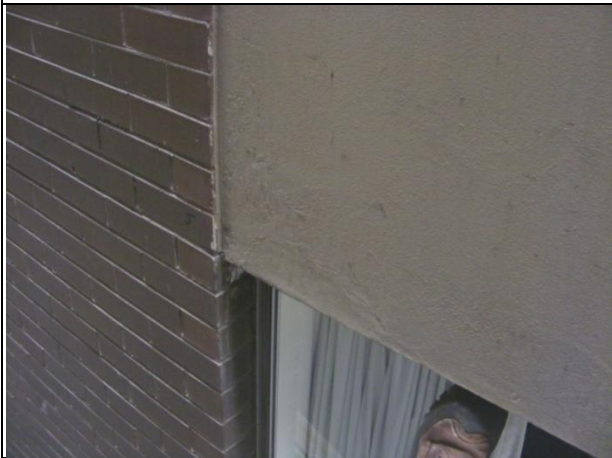
Ph #8741. Level 5 50% Drummy

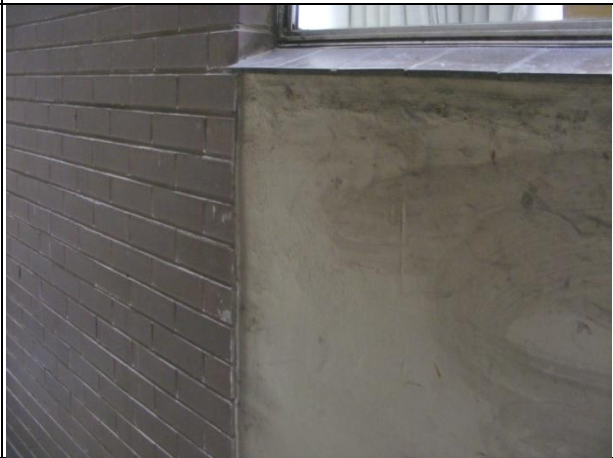
Ph #8742. Level 4. Very Drummy 60%

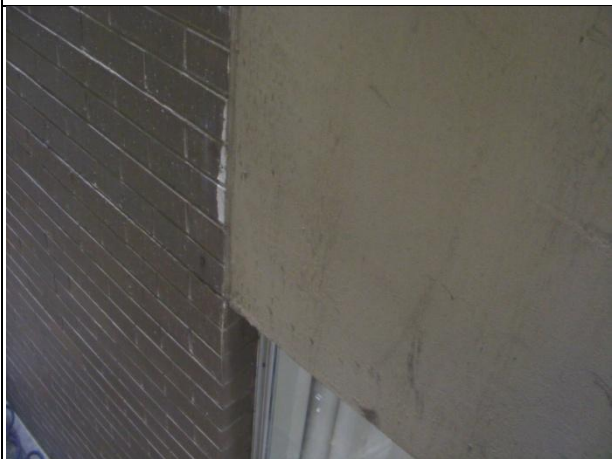
Ph #8743 Level 3. Very Drummy 60%

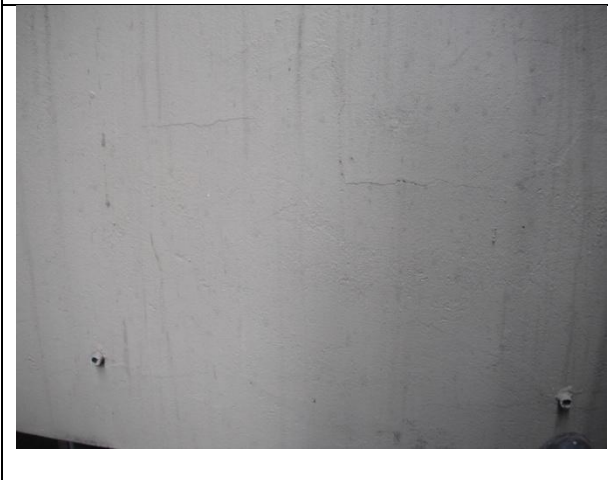
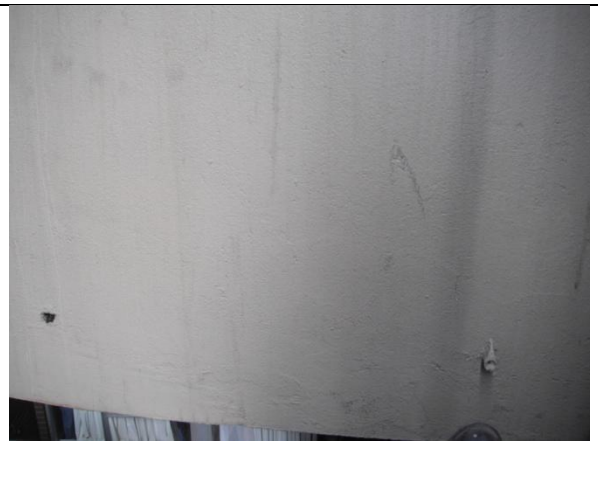
<p>Ph #5125 Level 8 Drummy Render</p>	<p>Ph #5129 Level 4 30% Render</p>
<p>Ph #</p>

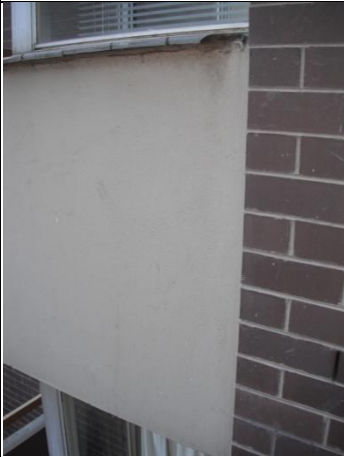
<p>Ph #5166 Level 9</p>	<p>Ph #5167. Level 7 10 Drummy in corners. Broken tile</p>

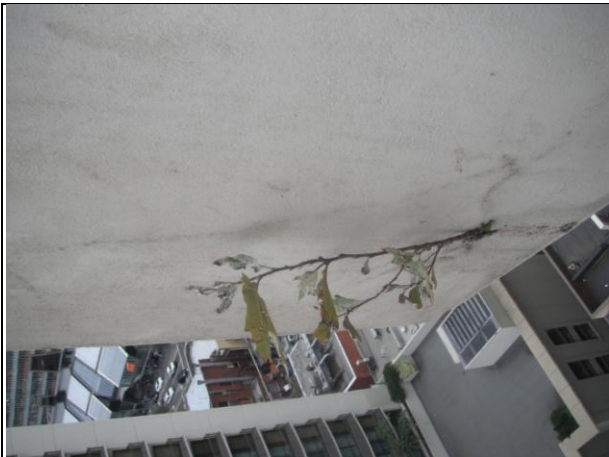
Ph #5184. Level 17 Drummy Render. Plant growing out of render

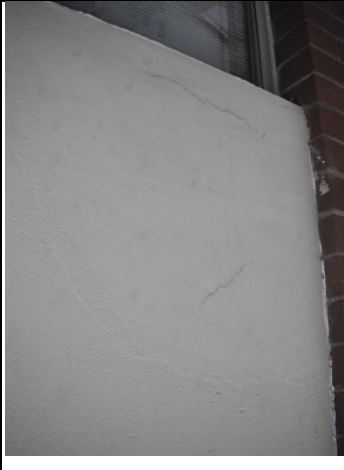
<p>Ph #5195 Level 17. Window Lintel Detail</p>	<p>Ph #5196 Level 17 Cracks in balcony render 30% drummy</p>

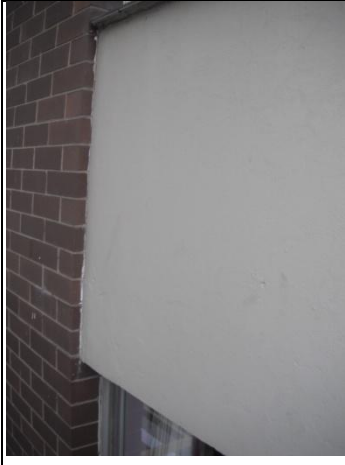
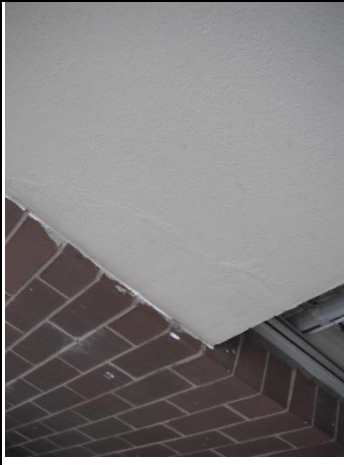
<p>Ph #5197 Level 12 Drummy Render 10%</p>	<p>Ph #5198. Level 11 Drummy Render 20%</p>

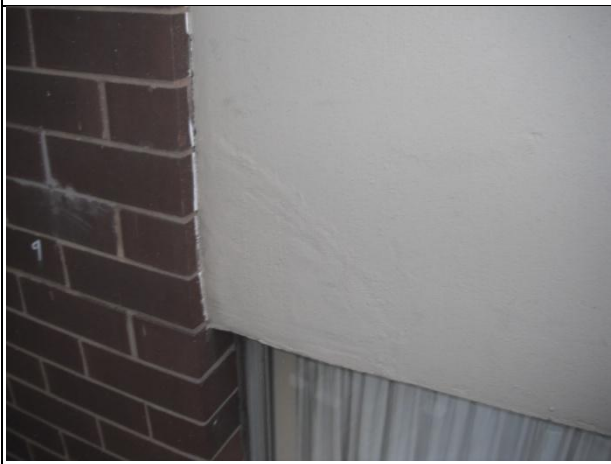
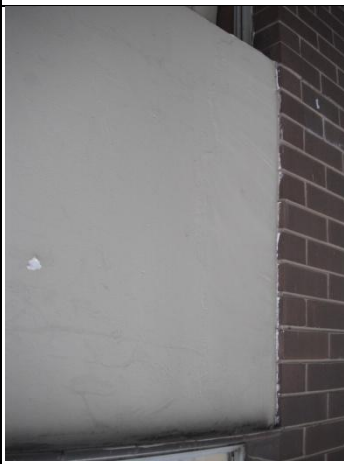
<p>Ph #5199 Level 10. Render 20% Drummy</p>	<p>Ph #5200. 20% Drummy left hand side towards wall</p>

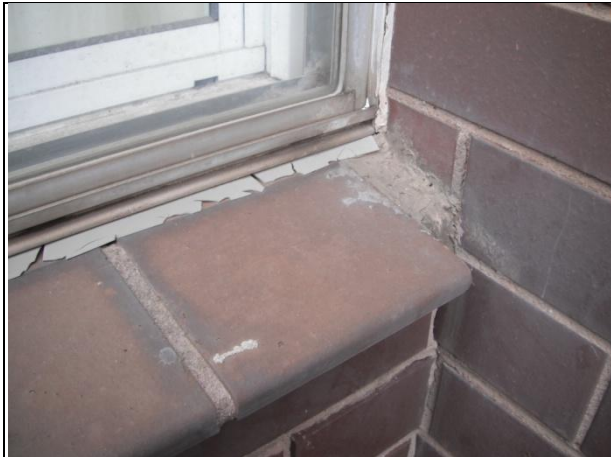
Ph #5526. Level 16 Bad Caulking
